# ETT 1962

## Touch Operating Panel

The ETT 1962 is an intelligent terminal for programming and visualization of automated processes. Process diagnostics as well as operating and monitoring automated procedures are simplified using this terminal.

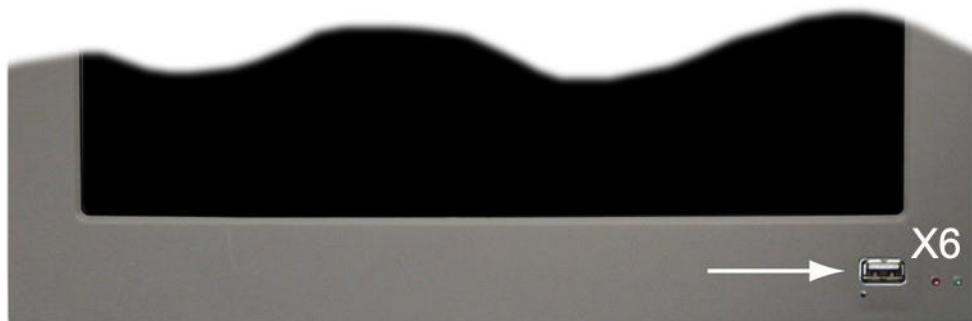
### 4.1 Front Connector

**X6: USB 2.0 Type A**

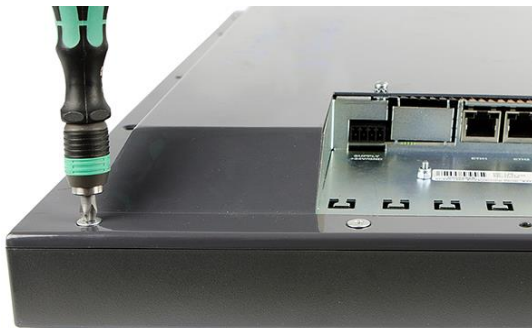
1. It is not necessary to save data on the microSD card. These are stored internally in a battery-buffered memory module (SRAM).
2. Disconnect the ETT 1962 supply. After the supply is disconnected, the real-time clock is buffered for at least 5 minutes after the battery has been removed.
3. Open the housing cover screws with a screwdriver.

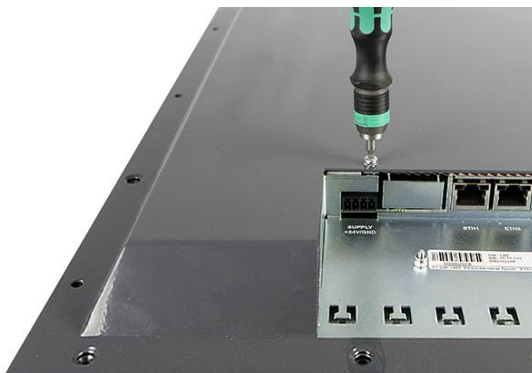
4. Open the 2 housing cover screws on the top with a screwdriver and lift the cover.
